YANMAR AMERICA CORPORATION

SERVICE ADVISORY

No: SA-09-004

SUBJECT: Proper Relay Orientation.

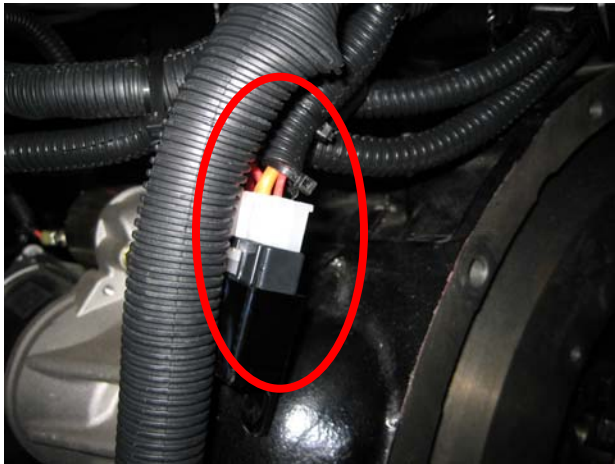
When installing a wiring harness onto a Yanmar Industrial Engine, it is imperative to install relays so they will not collect water in the connector. Additionally, dielectric grease should be applied to any unsealed connection, including relays, to help protect the terminals. Failure to properly install relays can result in excessive corrosion build up due to water/moisture collecting in the relay connector.

Incorrect Orientation
Water can pool in connector

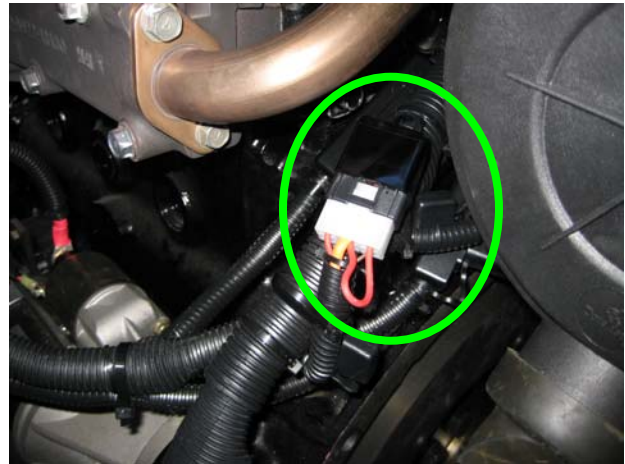
Correct Orientation
Water can drain from connector
